# **HAVANA GREAT THEATER**

## **Conservation Project**

**Training program Historic buildings  
and Conservation Management**

# Havana Great Theater: Conservation Project

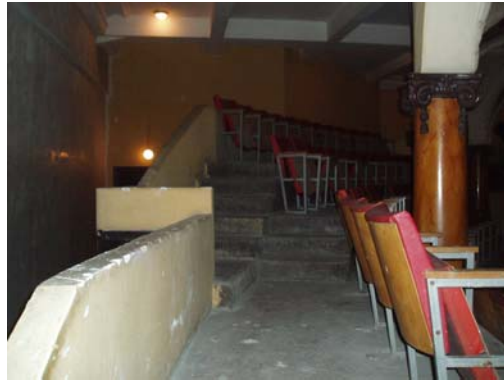
*figure 38: Corridors, masonry walls*

**The room has been modiflicated along its service life, in the year 1933 the central boxes of the first and second floor were suppressed to give bigger capacity to the room and also was installed a cabine for the cinema projectors in "Gathering". (Rey, 1988) (fig.33 and 34) In 1955 it was carried out the most important transformation that has have the Theater,the movable timber floor slab of "Platea" was substituted by a concrete one , the audience was arranged in 2 lines : 1 central and 2 lateral, (fig 36) the armchairs were substituted by cinema chairs, the louver doors of the boxes were eliminated, (fig. 37) the tiers of the high floors were substituted by individual seats (fig. 38) and the lobby area was reduced in order to use of the air conditioner system and also to be able to locate the offices. (Rey, 1988) (fig.35) In this time were built some steps of concrete in the seats area of each floor, in these steps is contained the air conditioner duits. Also the circulation corridor behind the last line of seats was reduced to be able to place 2 or 3 additional lines of armchairs and masonry walls were built to limit this space. (fig. 38)**

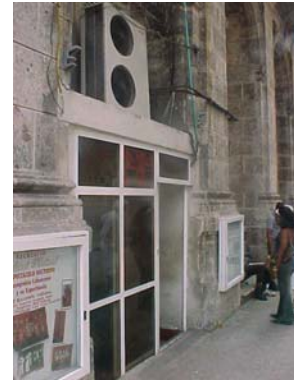
In some moment the alignment of the San Rafael's facade was broken, to create an entrance to the National Cabaret and the original window was substituted by a door that, from the architectural scale and design, doesn't keep any relationship with the monument. (fig. 39 and 40)

*figure 39: National cabaret entrance*

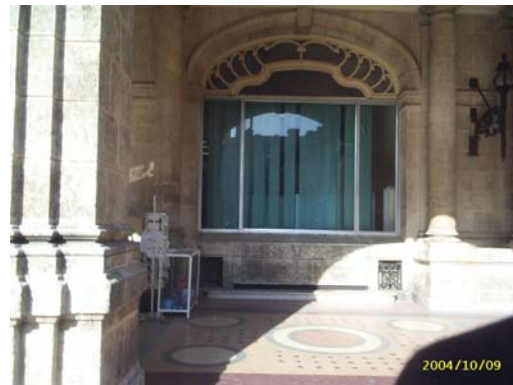
*figure 40: Post office entrance*

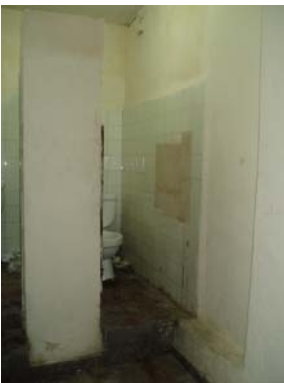
The water supply takes place through a cistern that pumps water toward some tanks located on roof and from there by gravity to the different places, but, as it is not enough the supply, that's why in each lavatory there is an independent tank with exposed installations to give service to the sanitary appliance of each area.( fig. 58 and 59)

*figure 58: Public Lavatories*

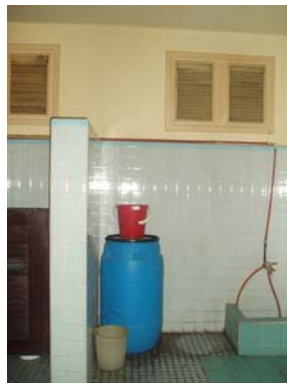
*figure 59: Public lavatory*

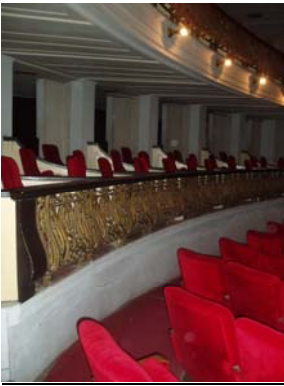
*figure 71: Existing railings*

- 10.1.7. **Forge:** The existents railings will be cleaned, rubed and painted. (fig.71)

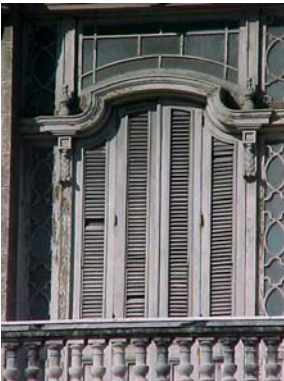
*figure 72: Real state - window*

- 10.1.8. **Doors and windows:** The external, those that have been eliminated or altered will be restored with the same design and all of them will be painted with the patterns of colors that its traces has indicated.(fig. 72 and 73)

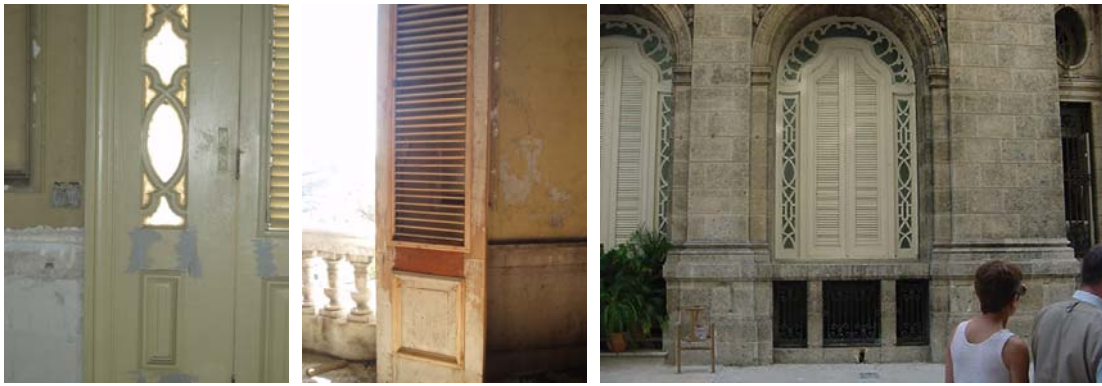
figure 73: Restored window

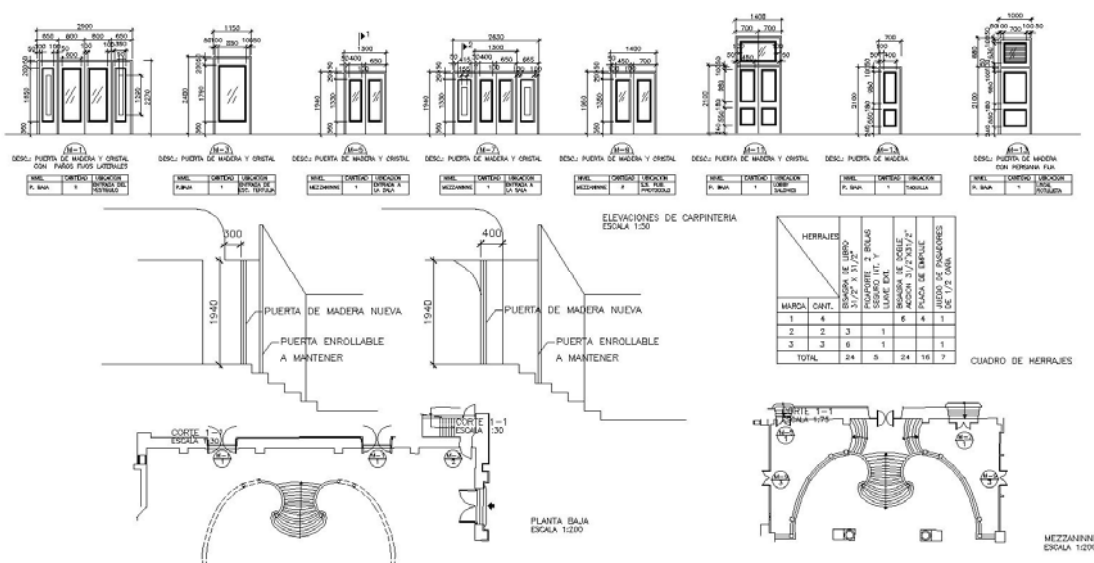
## Carpinteria Lobby

figure 74: Drawing for internal doors

The internal ones , those which are susceptible of restoration we will use the same approach mentioned before. Those that are very damaged or those that are new proposals of the project will be built using the existing design as reference. (fig. 74)

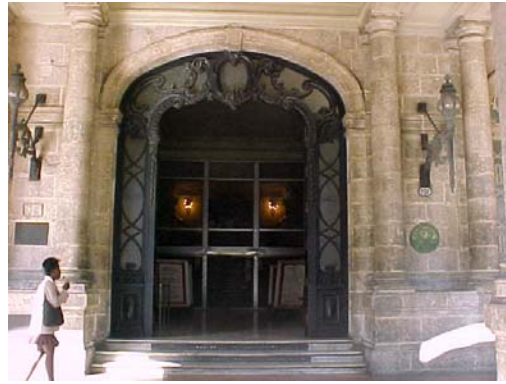
*figure 76: Lobby - Real state - year 2003*

- 10.1.9. Spaces: The space of the Lobby will be changed, recovering its original measures. (Fig.75, 76 and 78) Taking into account the wall paintings of the main walls, although they are not original but they belong to a recognizer painter (Tarragona) and they are part of the historical memory of the theater. (fig.79) We are studying the possibility of their transfer to other walls of the building.

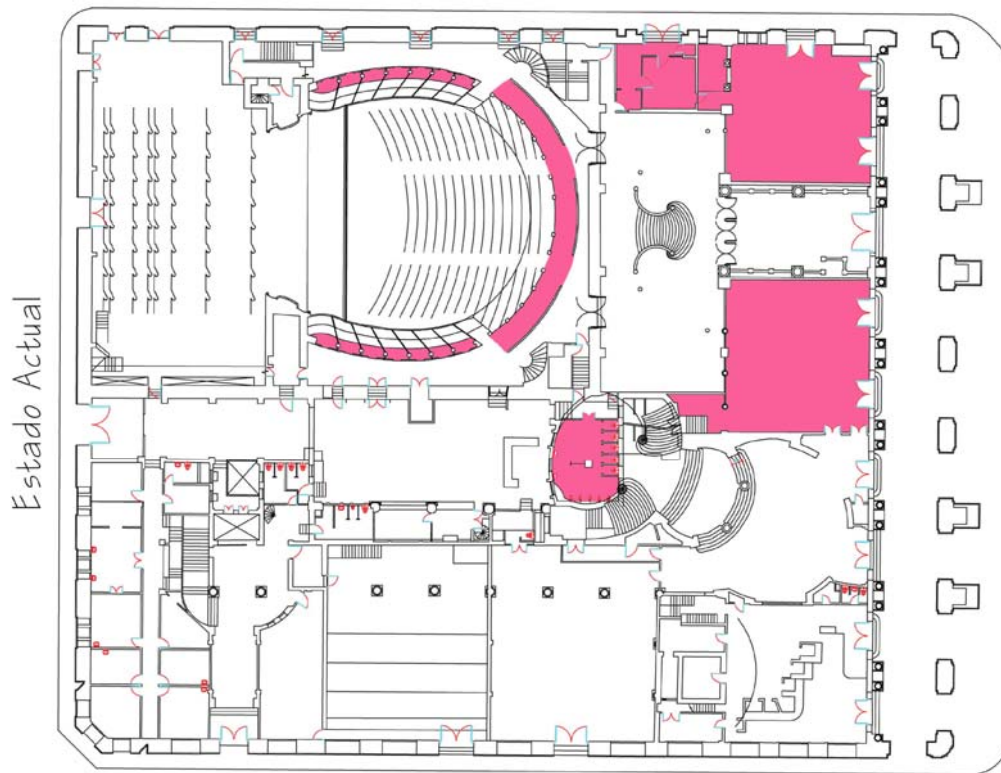
**figure 78: First floor- Real state**

**The horseshoes shape of the audience area will be recovered, starting with the elimination of the seats lines that were added and the masonry walls. (fig 79 to 88)**

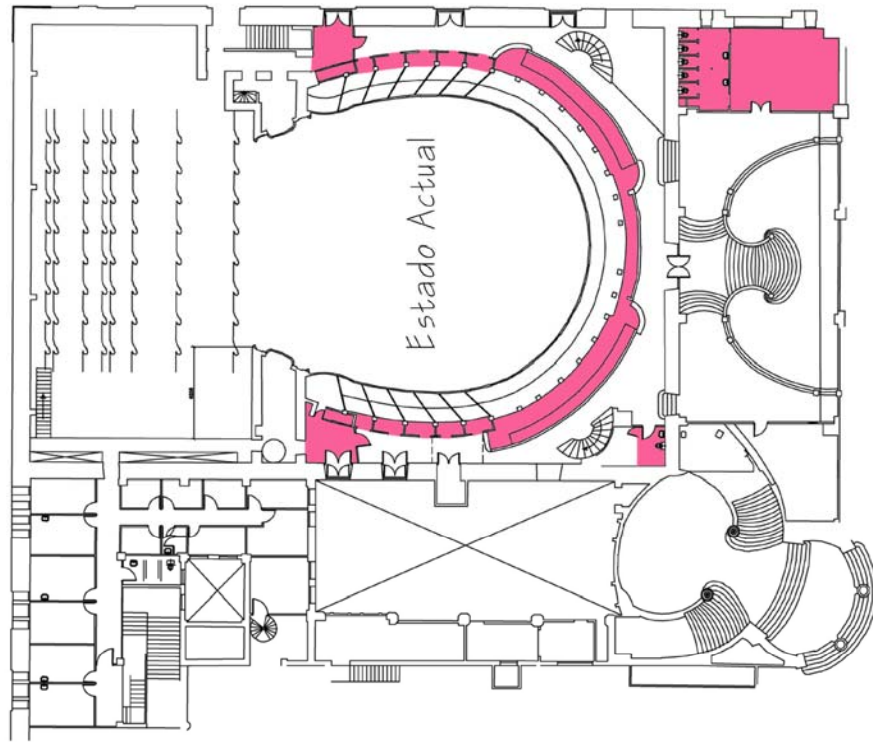
figure 80: First Balcony- Real state

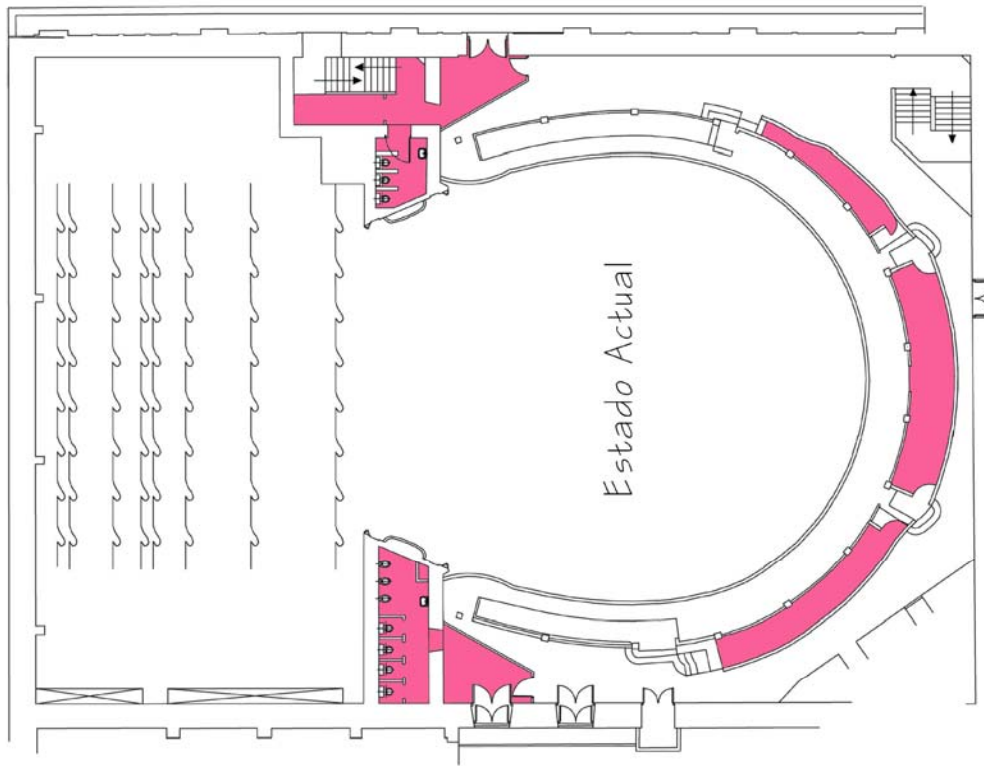
figure 82: Real state- Tertulia

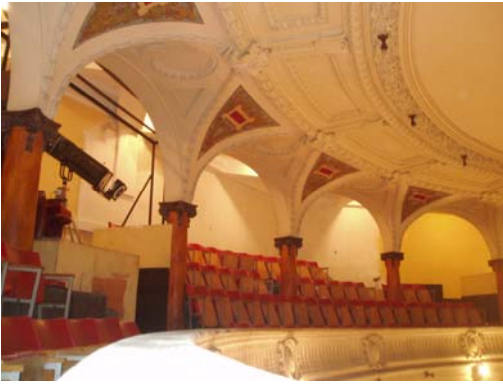
*figure 86: Paradise- Real state*

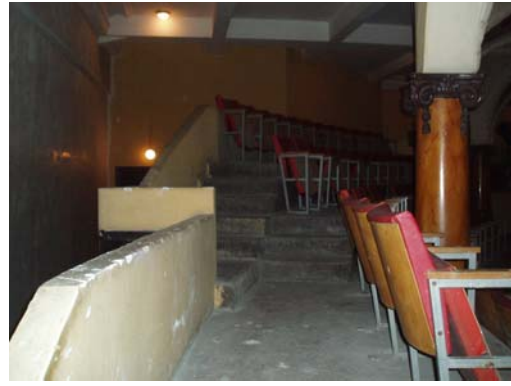
*figure 87: Tertulia- Real state*
