**BUILDING'S RENOVATION AT  
CONSERVATION AREA  
CASE STUDY: HOUSE IN TEUKU UMAR STREET 51,  
MENTENG JAKARTA.**

**DAVIS SYARIEF  
DEPARTMENT OF ARCHITECTURE  
INSTITUT TEKNOLOGI NASIONAL - BANDUNG  
INDONESIA**

**ADVANCED TRAINING PROGRAMME  
CONSERVATION & MANAGEMENT OF HISTORIC BUILDINGS  
26 SEPTEMBER - 13 OCTOBER 2005 IN LUND UNIVERSITY-SWEDEN  
20 FEBRUARY - 03 MARCH 2006 IN PNOM PHEN-CAMBODIA**

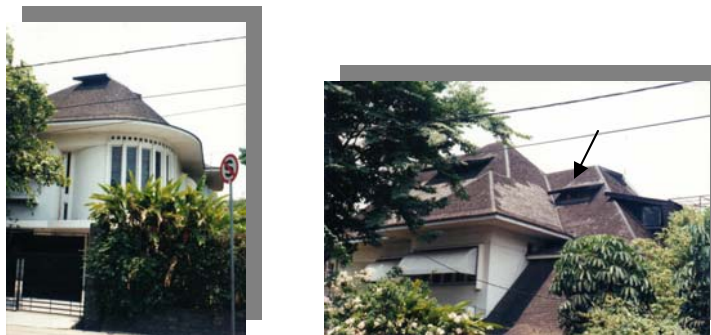
The most attractive and interest from this building is the round shape entrance at the corner. Beside main entrance this room functions also as connector to up level with stair on it. The circle stair connects the ground floor to upper floor.

Picture 11: The specific design: round main entrance and multi layer roof style.

Other specification is the roof style with shingled material which was popular at previous time. Shingled represented the exclusive house because of the most expensive roof material. Multi layers roof system with some ventilation on it was used to avoid the hot climate. This style is an old style and not popular anymore.

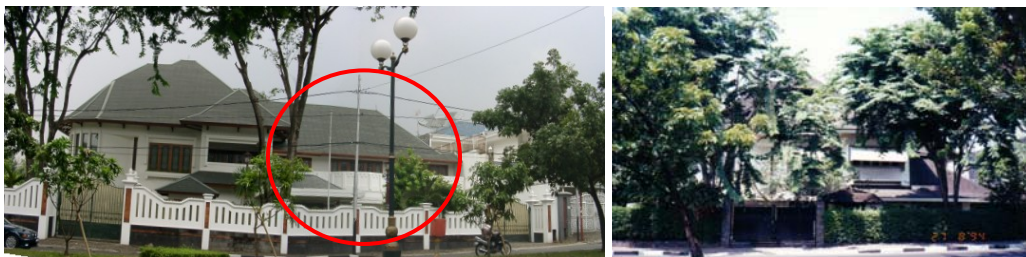
Picture 21: The building shape.

The basic shape is still the same but on the right part there is an additional building stretching out from the main part. This additional caused of the new owner's demand.
