CONSERVATION & MANAGEMENT OF HISTORIC BUILDINGS

Lund University

CONVENTION CENTER *CAXA REAL*

Work done by: Gustavo Bueso

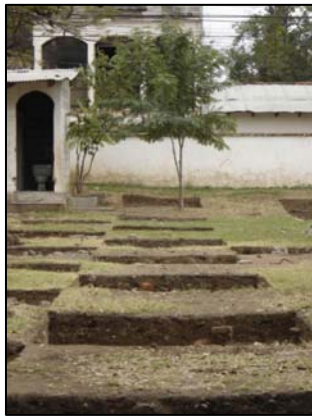
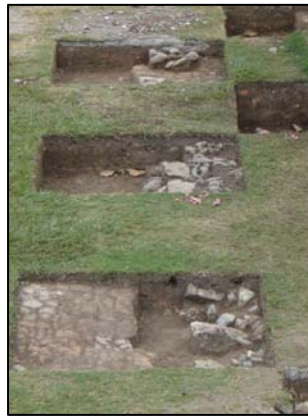
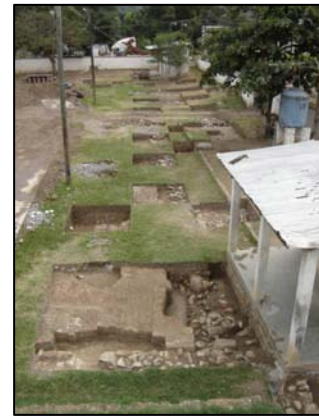
From the antique Caxa Real only approximately 60% of the frontal façade is still conserved, same that is found in a ruined state with a pathological problem reflected on the collapse toward the exterior of approximately 30 cm in the most critical sections of said façade. We also must mention that due to the abandonment of these ruins, there has generated an erosion process of the stone wall, due to the inexistence of fixing and the lack of treatment of seals of the base of land and lime. Adding to these problems, it also stands out the vegetation contamination of the ruins and the pronounciation of the collapse caused by the roots of these trees that grew next to this wall.

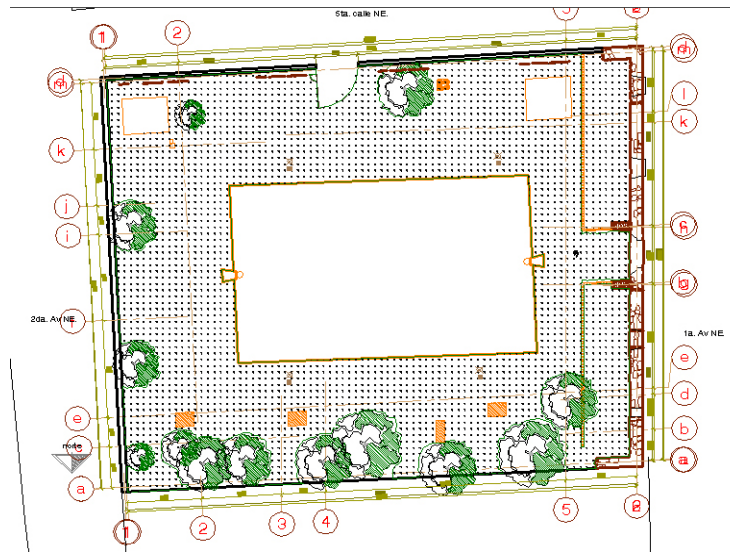
Present condition

Several natural events have seriously damaged the building and during a long period of time the property has remained abandoned, reaching an advanced state of destruction and acquiring the denomination of ruin. After two earthquakes the building had suffered some reconstruction work according original registration of the activities done but, it was after the fire and the moving of the capital to Tegucigalpa in the second half of the 19th century that the building became completely forgotten and abandoned.

Of the old antique Caxa Real or *Royal Box* only approximately 60% of the frontal façade is conserved, same that are encountered in a ruined state with a pathological problem reflected in the full towards the exterior of approximately 30 cm in the sections more critical of said façade. Given the state of abandonment of these ruins, a process of erosion, fungi and humidity has been generated on the stone wall due to the inexistence of repairs and the lack of treatment of seal of the unions in a base of soil and lime. Added to these problems, also the vegetation contamination stands out in the ruins and the pronounciation of the crumbling caused by the roots of the trees that grew next to this wall.
